DEPARTMENT OF TRANSPORTATION

Contract #: 04-0120F4Cty: SF/ALA Rte: 80 PM: 13.2/13.9File #: 69.28**WELDING INSPECTION REPORT****Resident Engineer:** Pursell, Gary**Address:** 333 Burma Road**City:** Oakland, CA 94607**Report No:** WIR-002282**Date Inspected:** 09-May-2008**Project Name:** SAS Superstructure**OSM Arrival Time:** 1400**Prime Contractor:** American Bridge/Fluor Enterprises, a JV**OSM Departure Time:** 400**Contractor:** Zhenhua Port Machinery Company, Ltd (ZPMC), Changxing Island **Location:** Shanghai, China**CWI Name:** Jiang Jian Fei, Xu Le Feng**CWI Present:** Yes No**Inspected CWI report:** Yes No N/A**Rod Oven in Use:** Yes No N/A**Electrode to specification:** Yes No N/A**Weld Procedures Followed:** Yes No N/A**Qualified Welders:** Yes No N/A**Verified Joint Fit-up:** Yes No N/A**Approved Drawings:** Yes No N/A**Approved WPS:** Yes No N/A**Delayed / Cancelled:** Yes No N/A**Bridge No:** 34-0006**Component:** Caltrans Tower**Summary of Items Observed:**

New Tower Bay 2

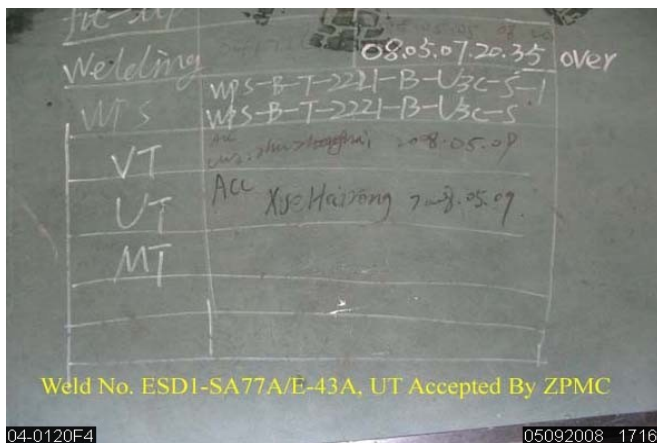
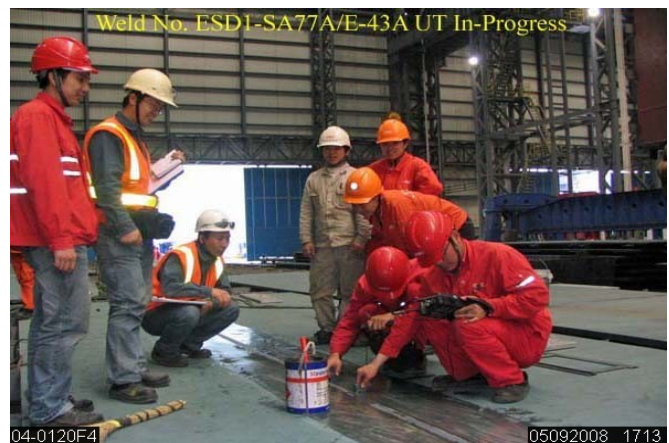
The QA Inspector randomly observed the ultrasonic inspection (UT) of Weld No. ESD1-SA77A/E-43A by ZPMC UT technician, Xue Hai Yong, who accepted the weld and marked acceptance adjacent to the weld. See attached pictures.

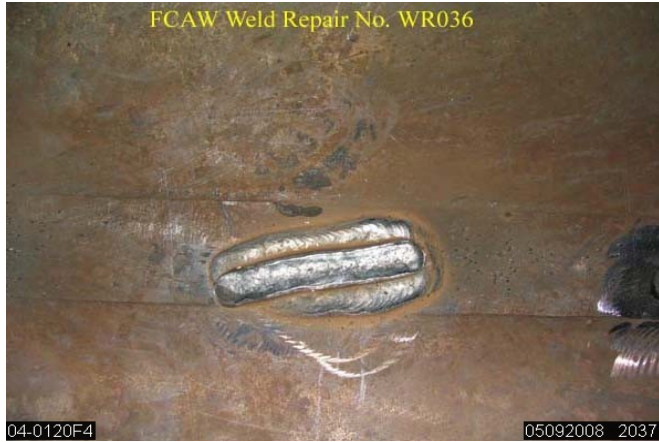
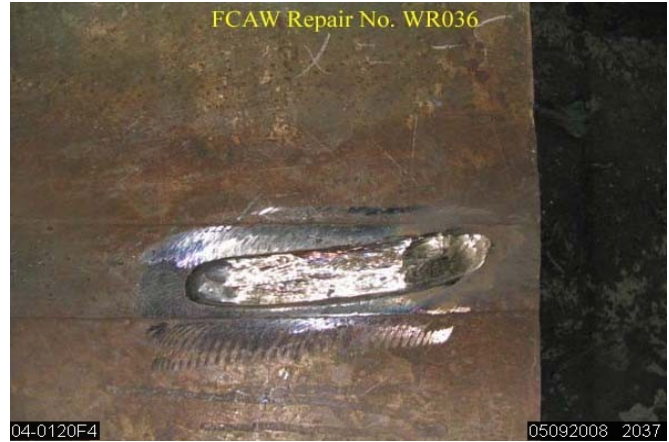
The QA Inspector also randomly observed the Flux Cored Arc Welding (FCAW) in the flat welding position 1G) on Weld Repair No. T-WR036. The welder was Bai Wei Ming (I. D. No. 040434) and the WPS No. was WPS-345-FCAW-1G(1F) Repair. Certified Welding Inspector (CWI), Xu Le Feng was present during this welding. See attached pictures.
